SPR 844

Evaluation of Curb Ramp Compliance: Review of Tools, Methods, and Time to Develop Error Tolerances

Northwest Transportation Conference

Oregon State University

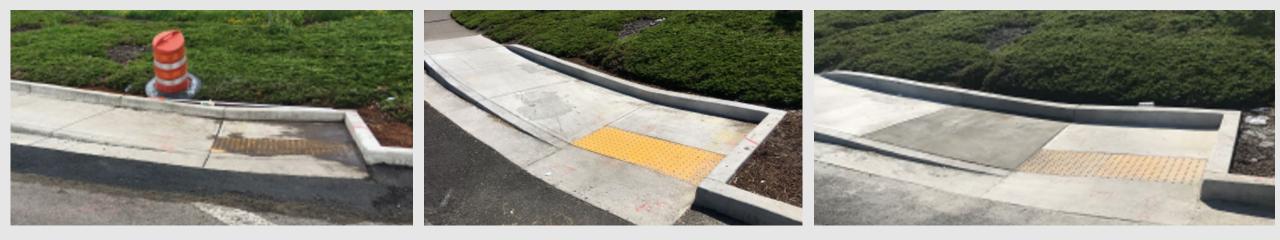
Example: Same Curb Ramp Inspected 3 times (altered adjacent ramp run, didn't alter landing)

- Landing Running Slope
 Landing Running Slope
 - Landing Running Slope

• <mark>1.4%</mark>

• <mark>1.2%</mark>

• <mark>1.3%</mark>

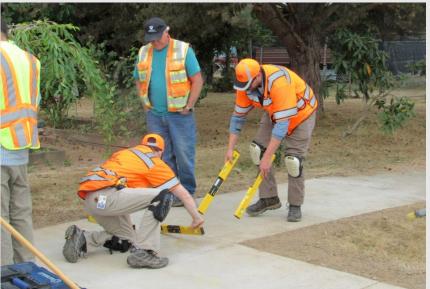
Measurement Error

- Device error using digital levels
 - Calibration
- Human Error
 - Measure in the same place
 - Straightness of placement

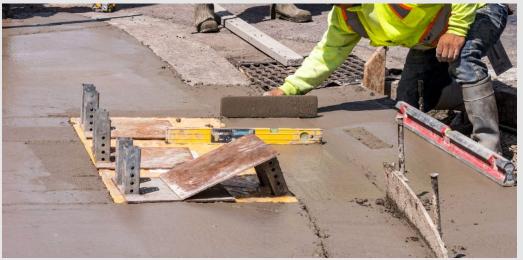
During curing

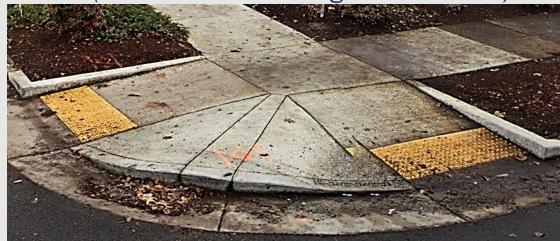
Effects of a point load (from vehicles running over concrete)

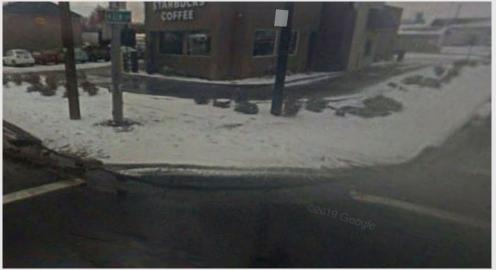
During freeze/thaw cycle

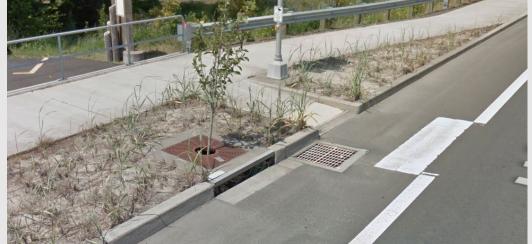
Consolidation of foundation materials

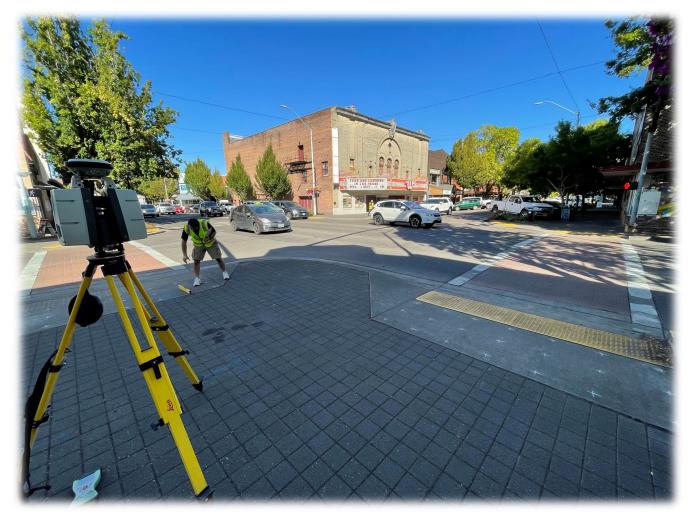
- **ODOT** Inspector Training Database (2022)
 - 64 ramps @ undisclosed location
 - 1942 running, 2114 cross slope measurements
- Ground Truth
 - ODOT Ground Truth
 - OSU Ground Truth

Photo is from different location to preserve anonymity of the site for certification tests.

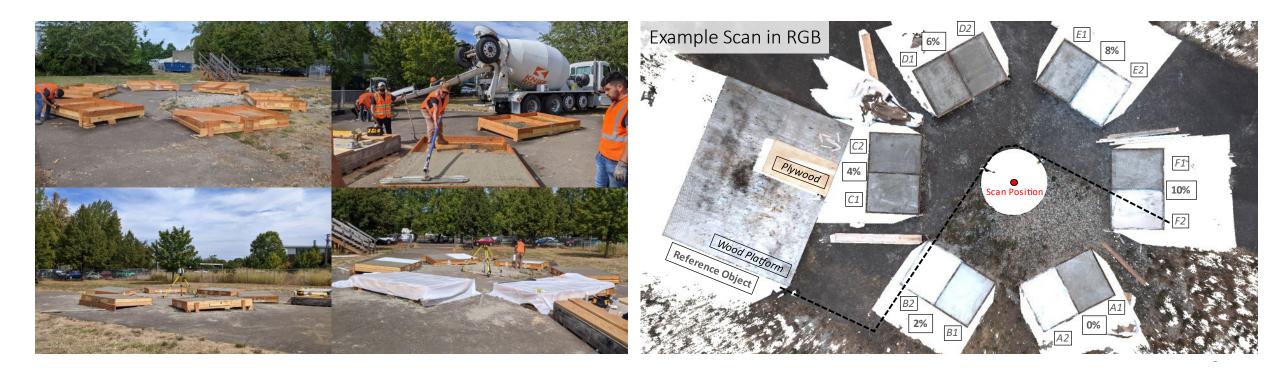
- 12 ramps with different curing methods and mixtures
- Running slope: 0% 10%
- 13 epochs of monitoring with TLS
 - 09/09/21 10/31/21

09/09/2021 - 09/11/2021

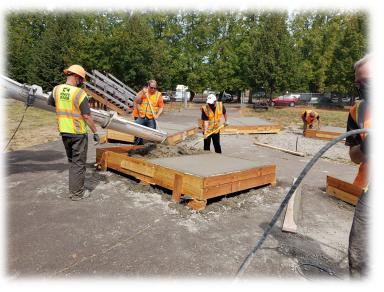
Stats	dAVG	dSTD	dMIN	dMAX	dMED	dN
AVG	-0.15%	-0.04%	-0.11%	-0.23%	-0.16%	-0.2
STD	0.13%	0.08%	0.27%	0.09%	0.15%	0.4
MIN	-0.34%	-0.23%	-0.38%	-0.39%	-0.38%	-1.0
MAX	0.10%	0.03%	0.63%	-0.09%	0.15%	0.0
MED	-0.16%	0.00%	-0.18%	-0.22%	-0.16%	0.0
RMSD	0.20%	0.09%	0.29%	0.25%	0.22%	0.4

Change of Running Slope from 9/9 to 10/31 via virtual smart level program

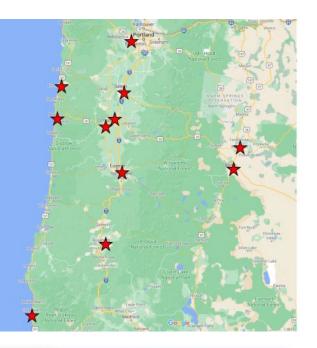
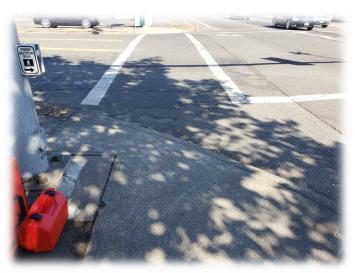
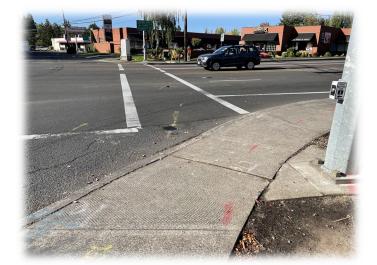
City	Location (number of	Date of initial	Date of
City	intersections)	survey	repeated survey
Corvallis, OR	Hwy 99W & SW Madison Ave (2)	09/01/2021	-
Albany, OR	Hwy 20 & First Ave SW (2)	09/01/2021	03/03/2022
Springfield, OR	Pioneer Pkwy & C St (2)	10/17/2021	-
Roseburg, OR	Hwy 138 & NE Jackson St (1)	10/07/2021	03/05/2022
Gold Beach, OR	Hwy 101 & 6 th St (1)	10/01/2021	03/05/2022
Newport, OR	Hwy 101 & SW Lee St (2)	09/02/2021	03/03/2022
Lincoln City, OR	Hwy 101 & NE 13 th St (1)	09/02/2021	-
Salem, OR	Hwy 99E & Pine St NE (2)	09/16/2021	-
Tigard, OR	Hwy 141 & SW Oleson Rd (1)	09/16/2021	-
Bend, OR	Hwy 20 & NE Revere Ave (1)	09/17/2021	-
Redmond, OR	Hwy 126 & SW 11 th St (2)	09/17/2021	03/08/2022

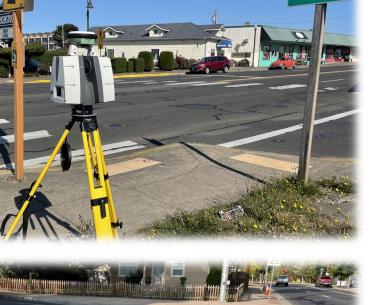
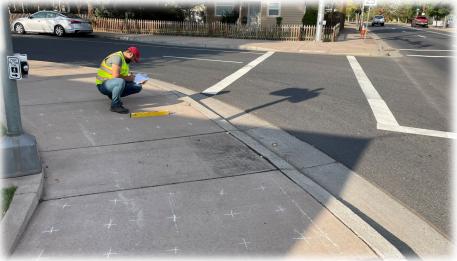
Field Workflow

- Laser Scanning:
 - Capture each ramp with P40/50 lidar scans
 - Geo-reference each scan with GNSS measurement (ORGN)
- Smart Level:
 - Calibrate the smart levels before the survey
 - Clean the curb ramps with brooms and brushes.
 - Mark survey locations (grid pattern @ 1.5 ft)
 - Measure and record slope measurements in both direct and reverse face at each mark
